Vintage Radio

Roberts R66 4-valve 2-band Portable Superhet

Roberts is a British brand previously not often seen in Australia although Roberts DAB+ radios have been on sale in recent times. In essence, this is not a restoration story but a straightforward repair of a set that was in fairly good condition.

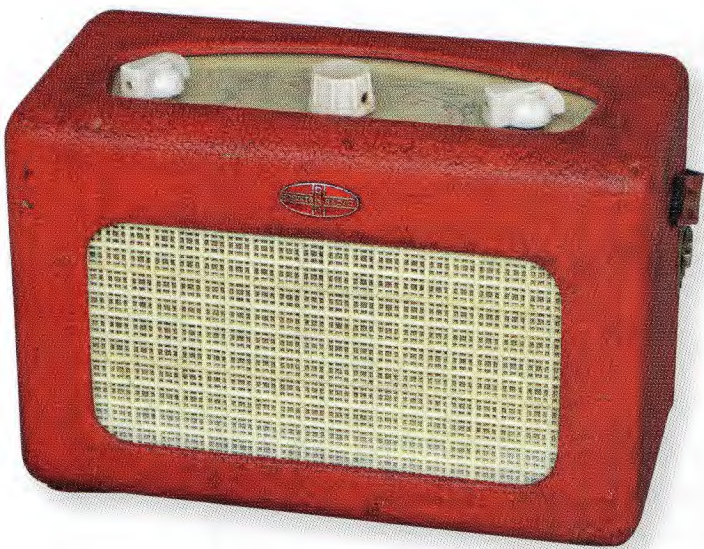
Shown above is the radio seated in its upright "playing" position. The speaker is located behind the grille, as shown in the photo to the right. The radio can run from either 200-250VAC mains or two dry batteries, one rated at 90V for HT and the other at 1.5V for LT.

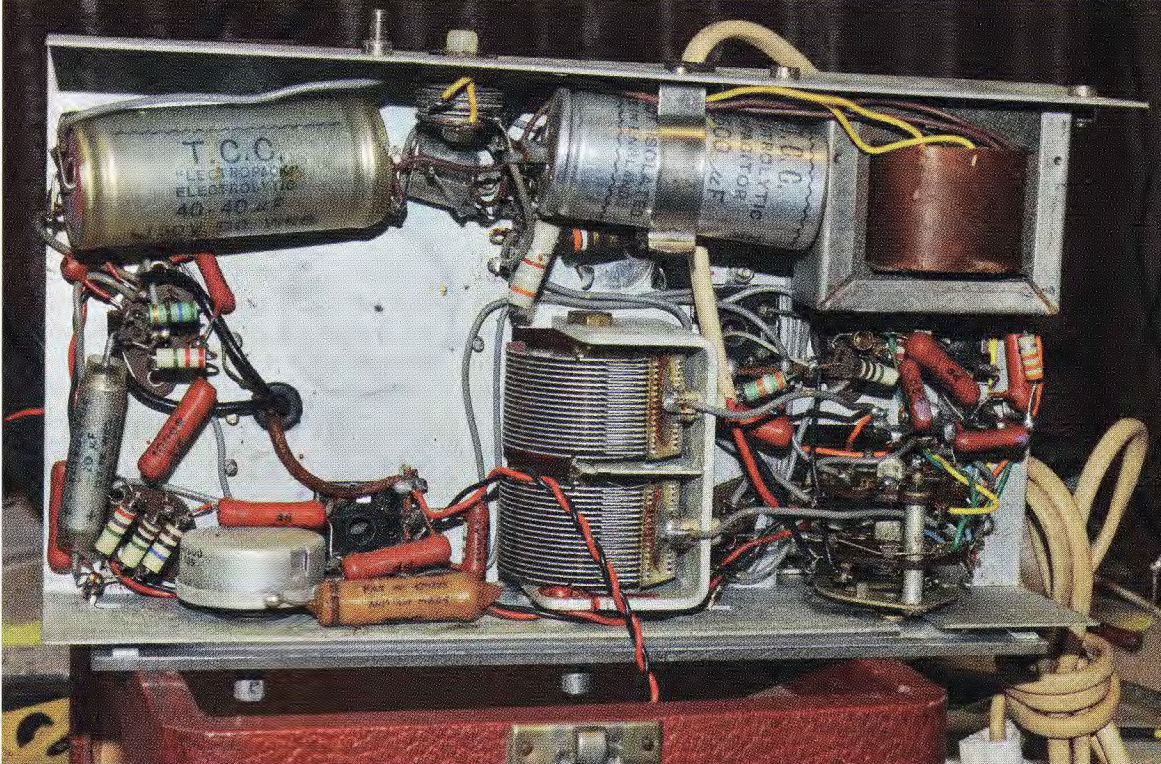
Shown left is the “bottom” of the chassis before restoration work had begun. Since the speaker is attached to the case, its leads need to be desoldered to completely free the chassis.
