Refurbishment of a Drake 2B Ham Bands Receiver – Gerry O’Hara

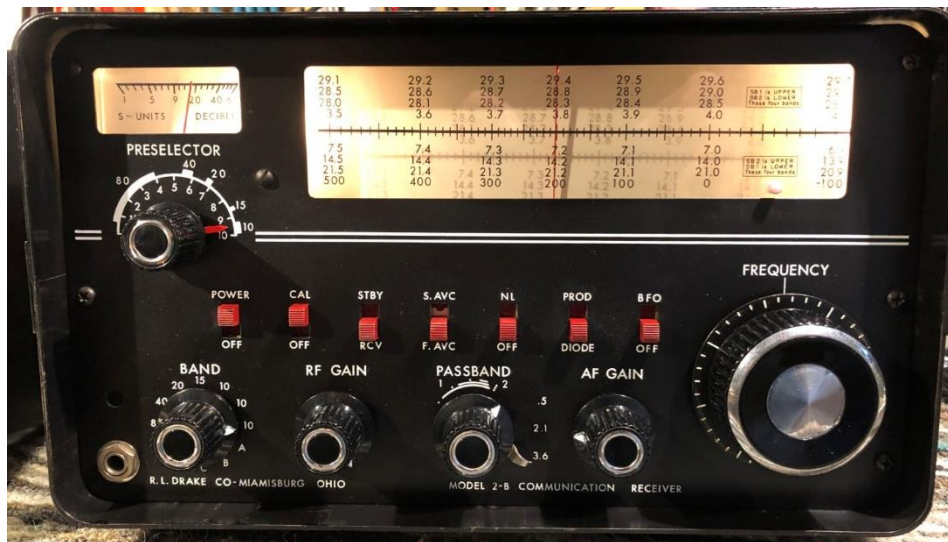
In 1959 they followed the 1A with the 2A, an equally compact but more traditional-looking receiver, having a horizontal form factor. The 2A had more features, increased sensitivity and selectivity, and was introduced at the same price as the 1A. It was followed two years later by the 2B (photo, below), very similar in appearance to the 2A, but with improved performance and a new set of controls for adjusting the selectivity (bandwidth) and center frequency of the passband. The Drake chassis of this era are distinguished by their copper plating, giving

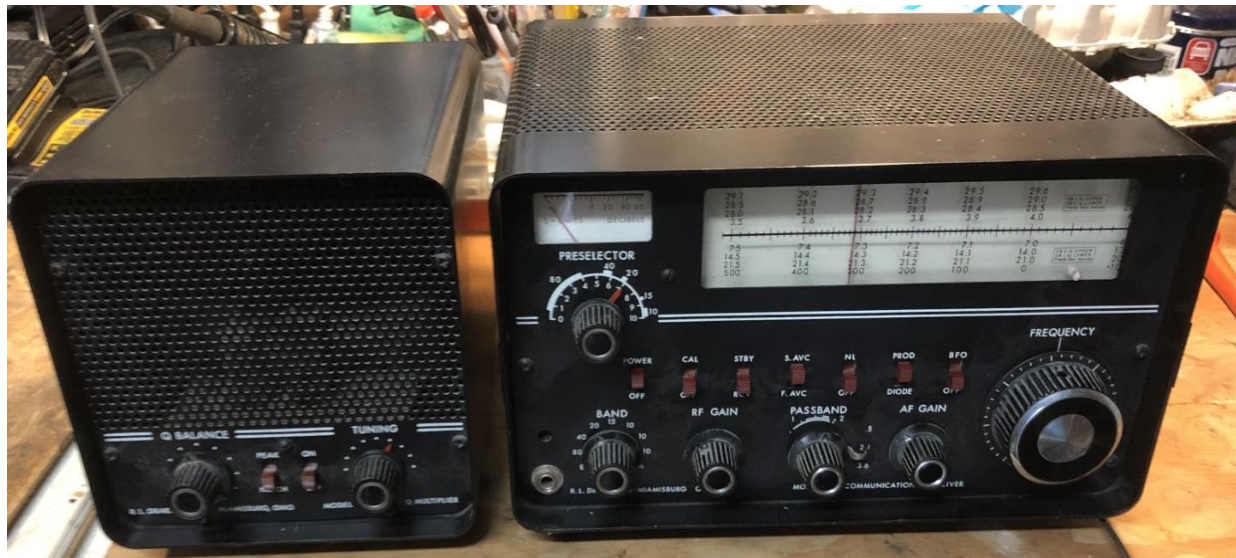
This example was in reasonable shape physically - some minor scratches on the front panel and metal case, and, as is typical for Drake receivers of this period and noted above, the thin copper plating on the upper side of the chassis is discoloured in patches with the underlying steel showing through as tarnished patches, all covered in a layer of dust and fluff – the photos below show the set and its matching speaker/Q-multiplier on arrival.

I vacuumed out the accumulated fluff and dust, cleaned the chassis with lighter fluid and alcohol, wiped the grime off the tubes, and then gave the chassis a preliminary inspection. This revealed some modifications to the power supply: a pair of silicon rectifier diodes and two 100 ohm series resistors had been added to the underside of the 6X4 rectifier socket, and a thermistor included in the power

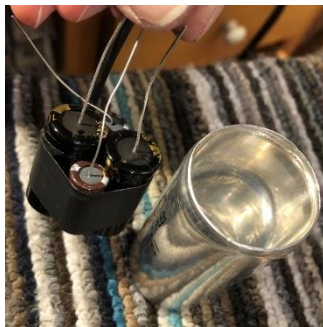
- opened up one of the white cardboard body tubular 0.1uF capacitors and found the dielectric used was plastic film. I re-stuffed the cardboard body with a new plastic film 0.1uF capacitor (photos, right), and decided to leave the other tubular capacitors alone for now as, being of the same type and therefore plastic film, they were likely to be ok;

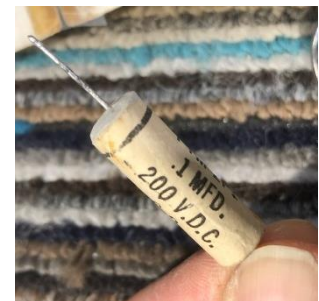
- removed the scruffy cardboard body multi-section electrolytic from the chassis. I tested each section and they had all failed either low/no capacitance, and all sections had high leakage;

- temporarily jury-rigged 2 x 100uF 450vw and 2 x 10uF 450vw electrolytics in its place, and then briefly powered-up the receiver, measuring the peak voltage on each capacitor - the highest voltage reached was 152vDC on one of the 100uF parts (reservoir capacitor), dropping to 150vDC working voltage - this is the 'beauty' of an indirectly-heated rectifier tube such as the 6X4² - virtually no cold switch-on voltage surge as all the tubes reach operating temperature almost at the same time. I therefore decided to used 160vw rated parts for all four capacitors - being physically much smaller than the equivalent capacitance 450vw parts, these would easily fit into a new can of the correct size for this chassis;

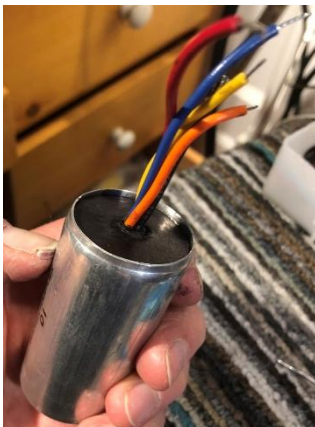
- found a suitably-sized old aluminum can capacitor, gutted it and stuffed it with 2 x 100uF 160vw and 2 x 160vw 10uF 105C rated new electrolytics (photos, left). I recycled the wires off the removed cardboard body

capacitor onto the new capacitors, and installed the new capacitor assembly onto the chassis with an appropriate clamp removed from a scrap chassis;

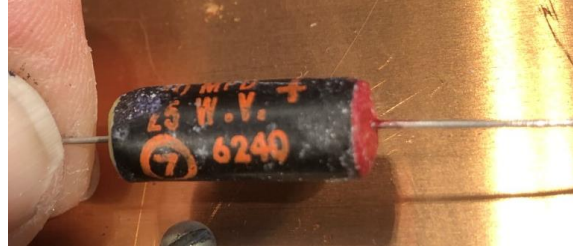
- re-stuffed the 10uF 25v electrolytic cathode bypass capacitor on the output tube. This is a brittle (ceramic?)-bodied part with ceramic(?) ends, and consequently it was difficult to remove the old 'guts', and parts of the sleeve broke off during this process. The damage was repaired with epoxy putty and then coloured black/red/yellow per the original using a permanent marker pens (photo, right) before re-installing into the chassis;

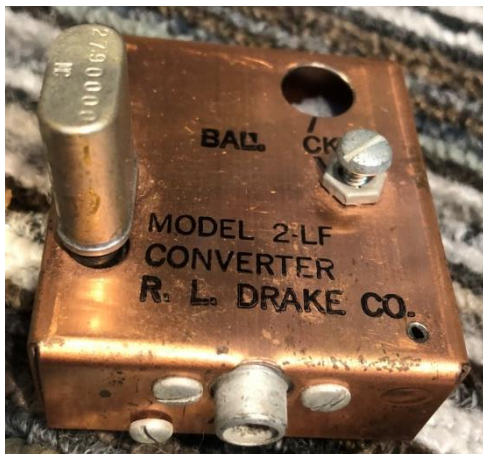
I had tried out the '2-LF' low frequency converter unit that came with this set (photo, left) once the receiver was initially functioning, but it was not working. Focussing on optimizing performance of the 2B chassis, I had put it aside, but now decided to try it again. I soon figured out why it was not working when I had tried it previously: the crystal calibrator switch must be set to 'on' as (obviously) the unit derives its power from the calibrator socket (doh!) - however in mitigation, the 2-LF manual does not state that anywhere in its set-up instructions...

This unit actually works reasonably well considering its simplicity. It comprises a single transistor crystal oscillator and aperiodic diode ring mixer that up-converts the low frequency signals to the 10M bands. This 2-LF unit was supplied with both crystals enabling signals from 100KHz to 3.5MHz to be received, allowing coverage of the Broadcast Band and the 160M ham band. Being wide-band, the unit will not have a great cross modulation performance, however, for general reception on the Broadcast Band it is perfectly adequate.

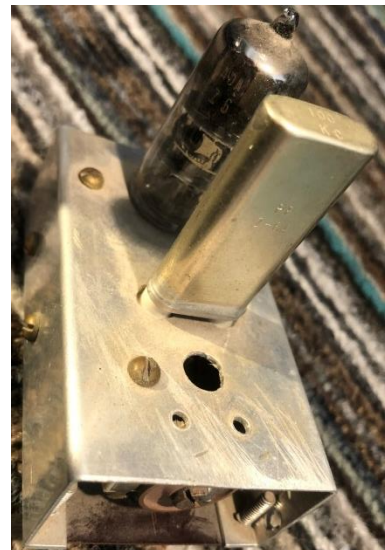
The home-brew crystal calibrator unit (photo, right) was then checked and found to be bang-on frequency (100KHz), with harmonics audible on all bands (this is a copy of the Drake calibrator circuit).

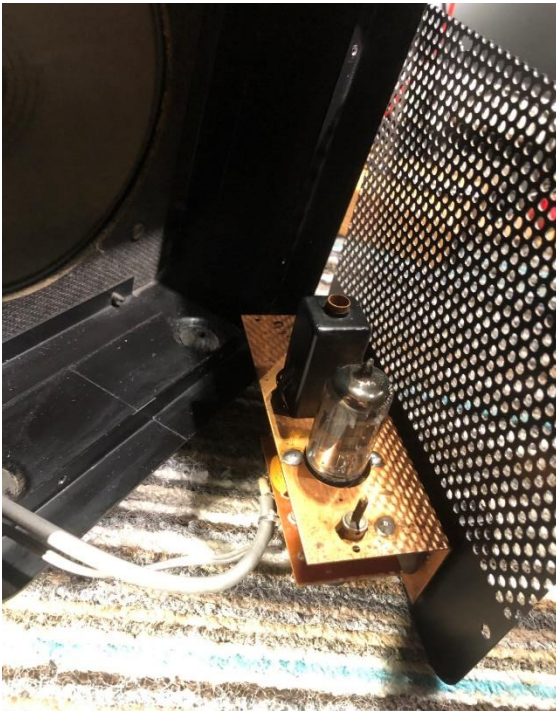
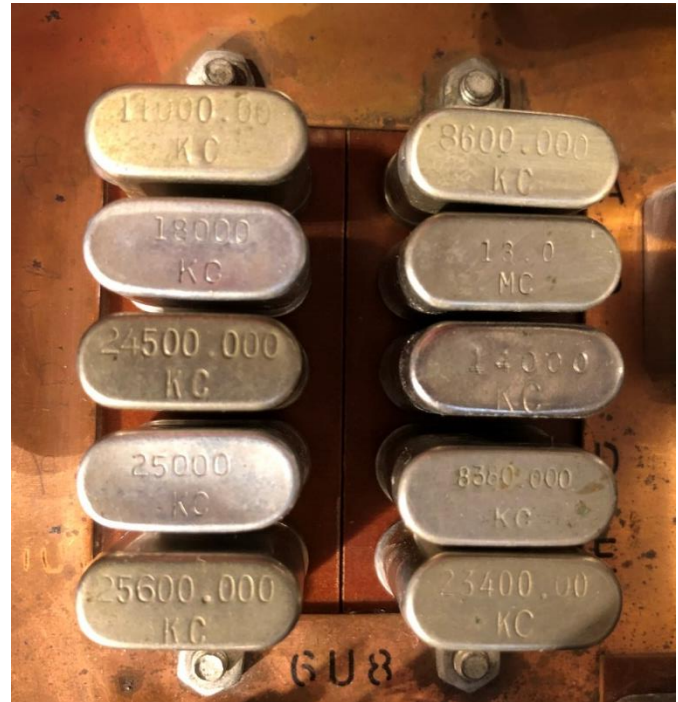
Above left: Q-Multiplier chassis after clean-up. Above right: crystal bank on the 2B chassis - the left-hand row is the standard ham band set of crystals, and the right-hand row is for 'auxiliary' frequency coverage crystals. Below: the 2B front panel after refurbishment, here receiving a station on the Broadcast Band with the 2-LF converter installed (upconverting to one of the 10M bands)

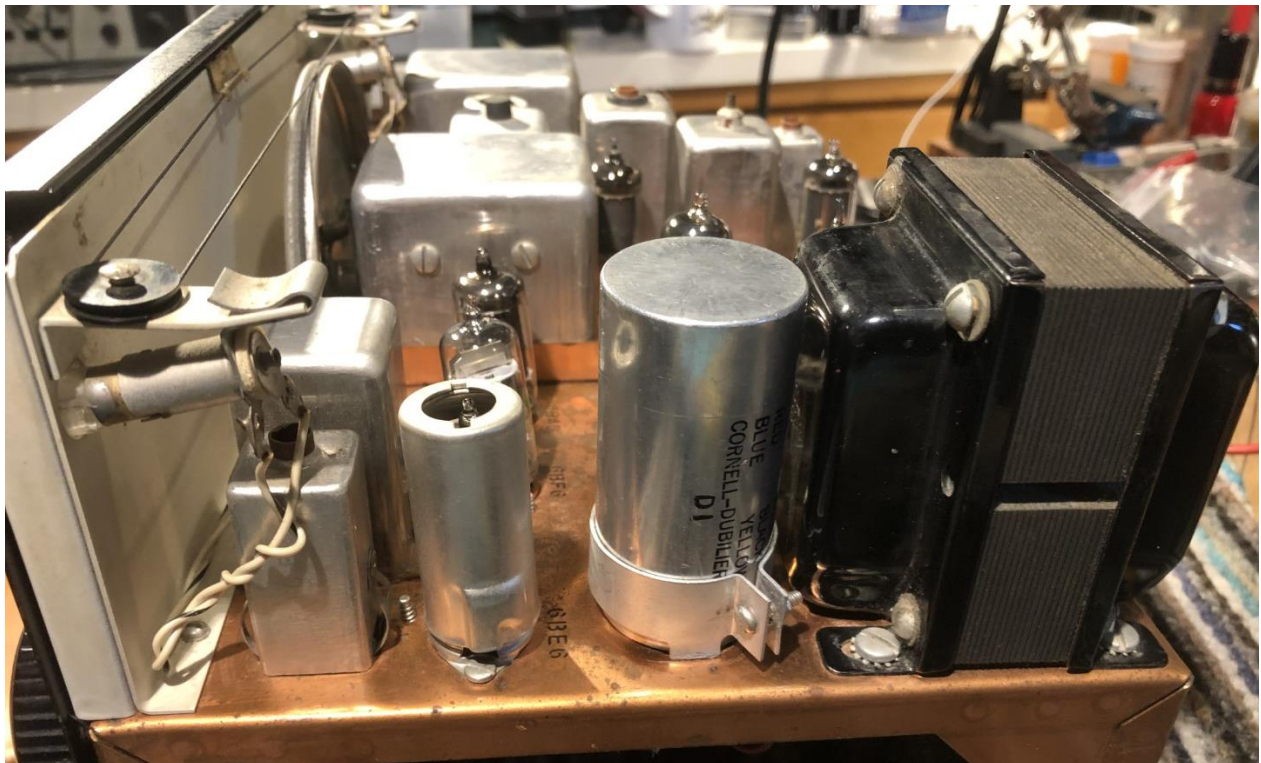
Above: chassis after cleaning and refurbishment – pity about the state of the copper plating. The crystal calibrator /2-LF socket can be seen lower-centre. Below: the replacement (re-stuffed) electrolytic can installed on the chassis – looks much like the original fitment

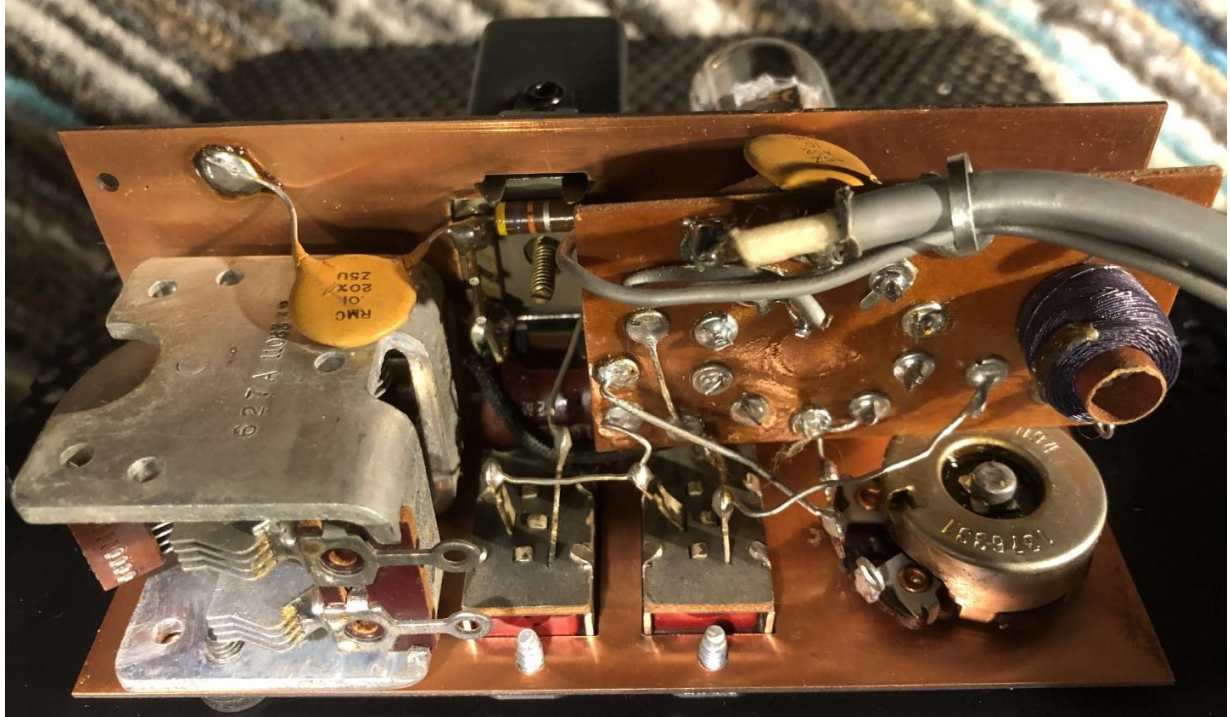
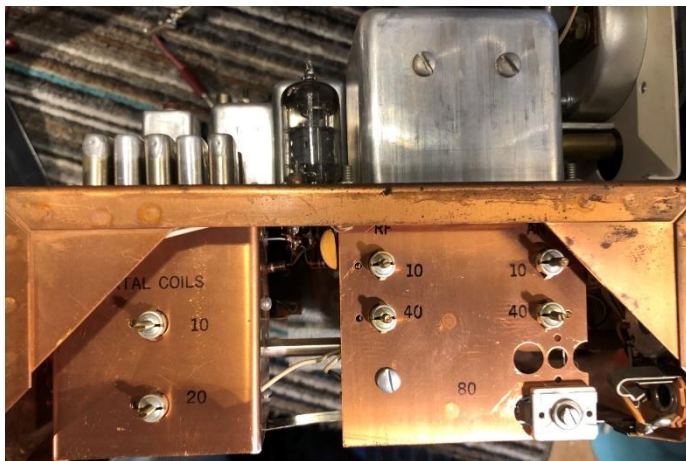
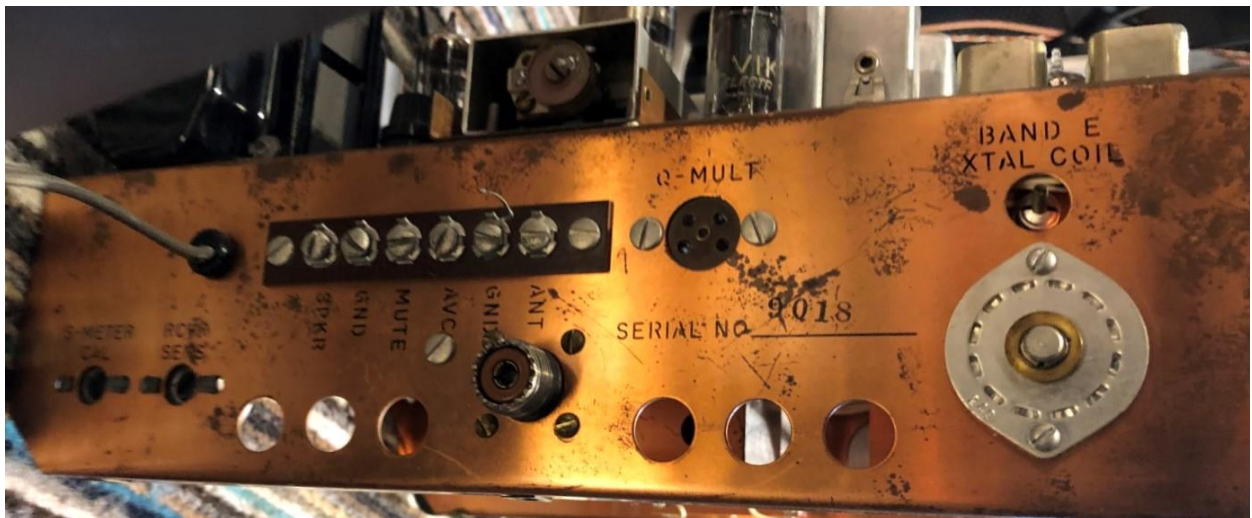
Above: underside of the Q-multiplier chassis – a simple but very effective circuit. Left: side of chassis showing the preselector adjustment slugs and trimmer. Below: rear apron showing Band E preselector adjustment slug, Q-multiplier socket, antenna and other connections. The two trimmer pots on the left hand side are for S-Meter sensitivity and 'Receiver Sensitivity' (actually AGC 'bias' or delay)
